# Evaluation of damaged DHSV

## enables planning for an optimised remediation

### Case study: **SPACE® Panorama**

High resolution evaluation of a damaged DHSV, comprising measurements and 3D images, enables planning for an optimised remediation.

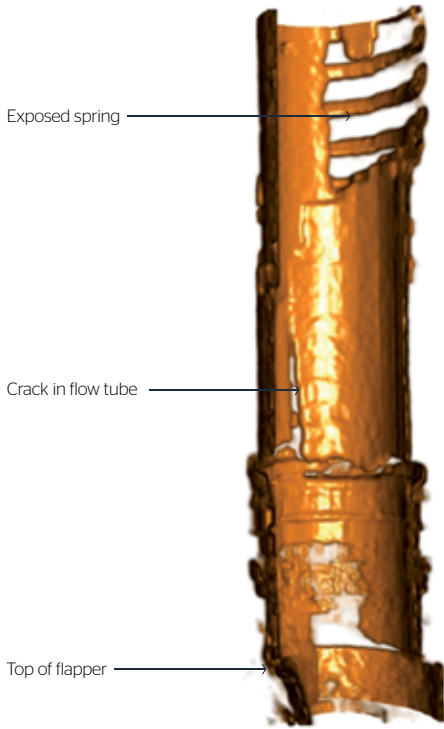
The data revealed not only the flapper position as being partially open, but also that there was considerable damage to the flowtube such that the normally concealed spring was fully exposed to the wellbore. In addition, a number of holes were found to be present. Clearly, the damage was too extensive to consider repair so a straddle solution was designed. The precise internal measurements acquired allowed the design of a straddle to be anchored in the original DHSV upper and middle seals, with a surface-controlled insert safety valve hanging off from it, locking open the original valve. Control of the well was restored and it was successfully converted into a valuable oil producer.

3-D rendering of **SPACE® Panorama** Viewer data from the DHSV. Severe damage to the flow tube revealed.

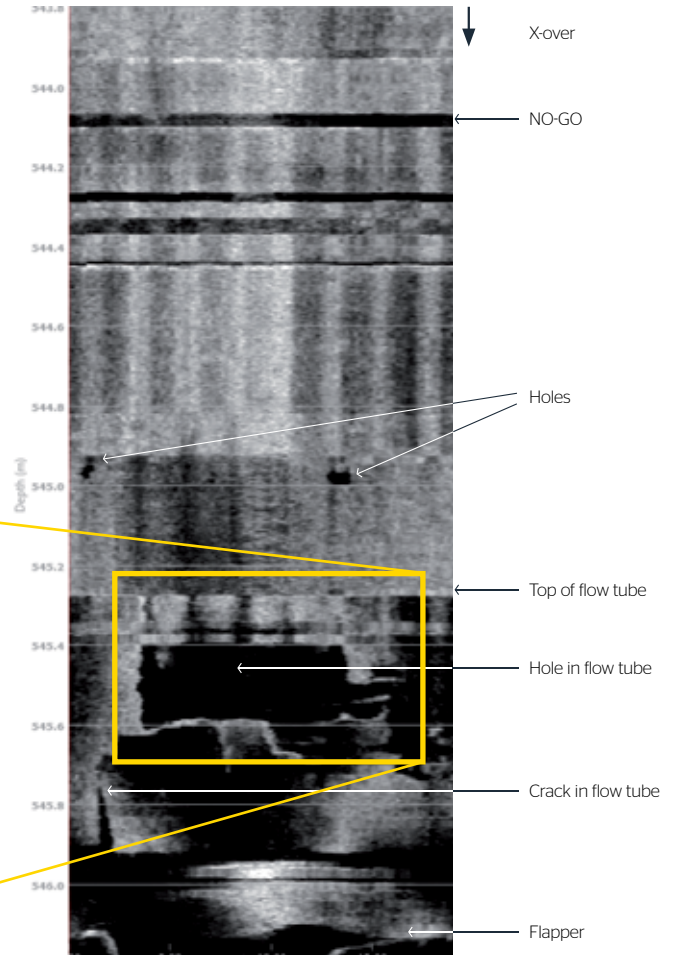
3-D rendering of **SPACE® Panorama** data from the entire DHSV assembly, showing damage to the flowtube while confirming dimensions and condition of seal bores and profiles.

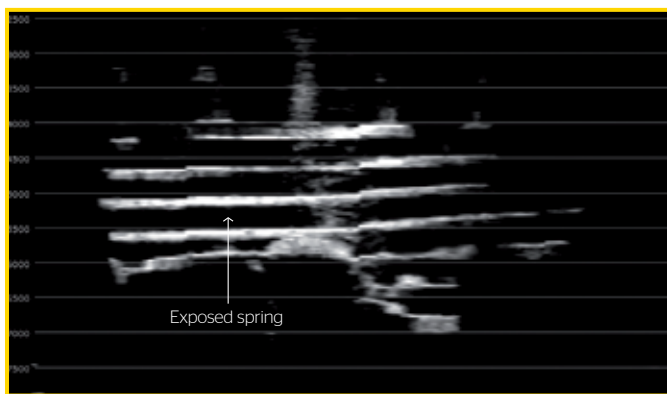
Ability to adjust focal length allows **SPACE® Panorama** to "see through" the hole in the flowtube and image the spring behind.
