High-resolution measurements

to reveal damage to a TRSSSV

Case study: **SPACE® Vernier**

Region: North Sea
Customer: Maersk
Well Type: Producer

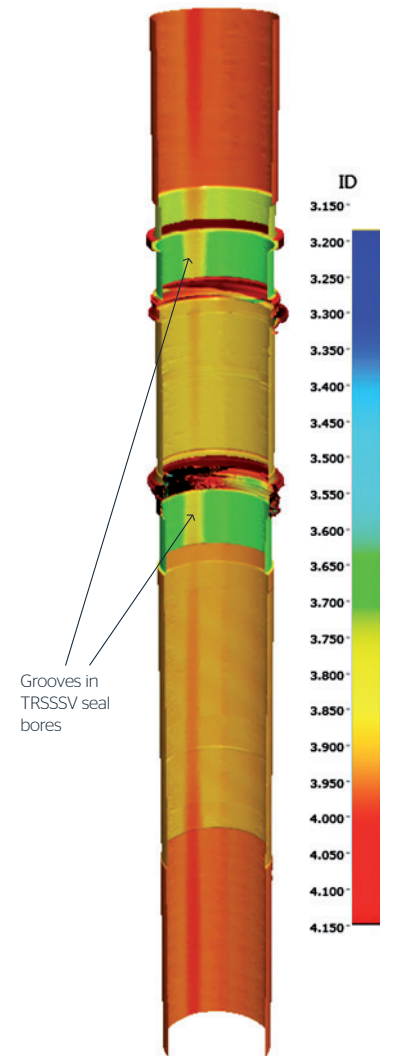
The **SPACE® Vernier** tool, with its high resolution measurements of both internal diameter and wall thickness, was chosen to identify the reason for the TRSSSV's inability to seal and to evaluate the condition of the tubing to surface. Survey data acquired revealed a groove running from below the safety valve all the way to surface and was visible throughout the TRSSSV, including the seal bores. The high circumferential resolution (288 samples) of **SPACE® Vernier** allowed precise measurement of the width of the groove (averaging 0.5") while the maximum depth was measured at 0.05" through the seal bores, clearly explaining the inability of the valve to seal correctly. In the data recorded above the valve, the tubing appeared in generally good condition with the exception of a consistently narrow (no more than 0.5") groove indicated by increased ID measurement. Corresponding directly measured thickness readings

3-D rendering of **SPACE® Vernier** ID data from the TRSSSV. Signs of wear appear all the way through the TRSSSV.

revealed reductions in remaining wall thickness of up to 21% at the point of the groove, while the remainder of the wall maintained largely nominal thickness. Taken together, the high resolution internal diameter and thickness data indicate that there is very little general corrosion or metal loss in the tubing as a whole, but that there is localised wall loss of up to 21% due most probably to physical wear.

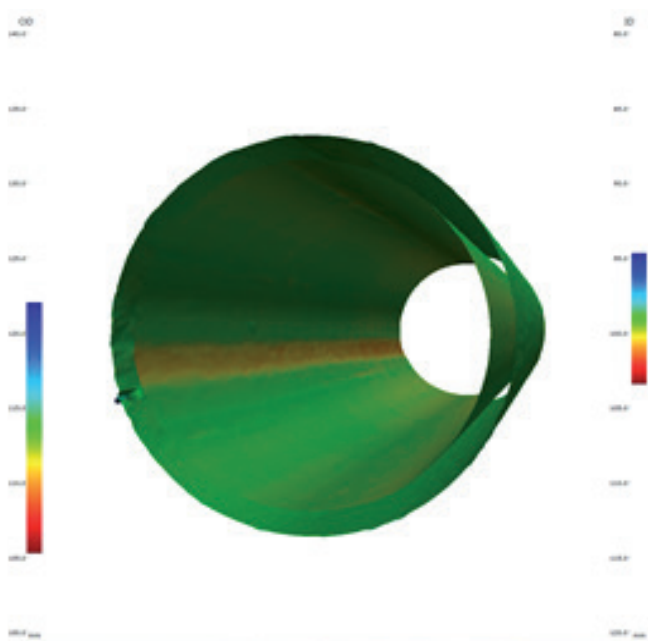
3D rendering of inner and outer diameter. The outer surface of the completion seems to be in good condition (green color).

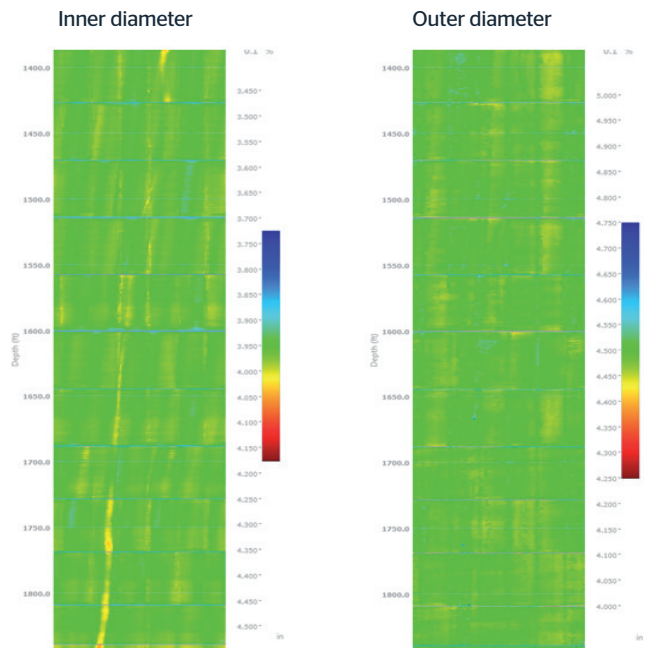
Direct inner and outer diameter measurements reveal that the damage (yellow/orange color) has occurred on the tubing's inner surface. Here showing the depth interval from 1380 ft to 1850 ft.
