# Evaluating injection erosion

## Thickness accuracy avoids misunderstanding

### Case study: **SPACE® Vernier**

A high rate water injection well was evaluated to determine if the rates were sustainable in the long term without promoting excessive erosion.

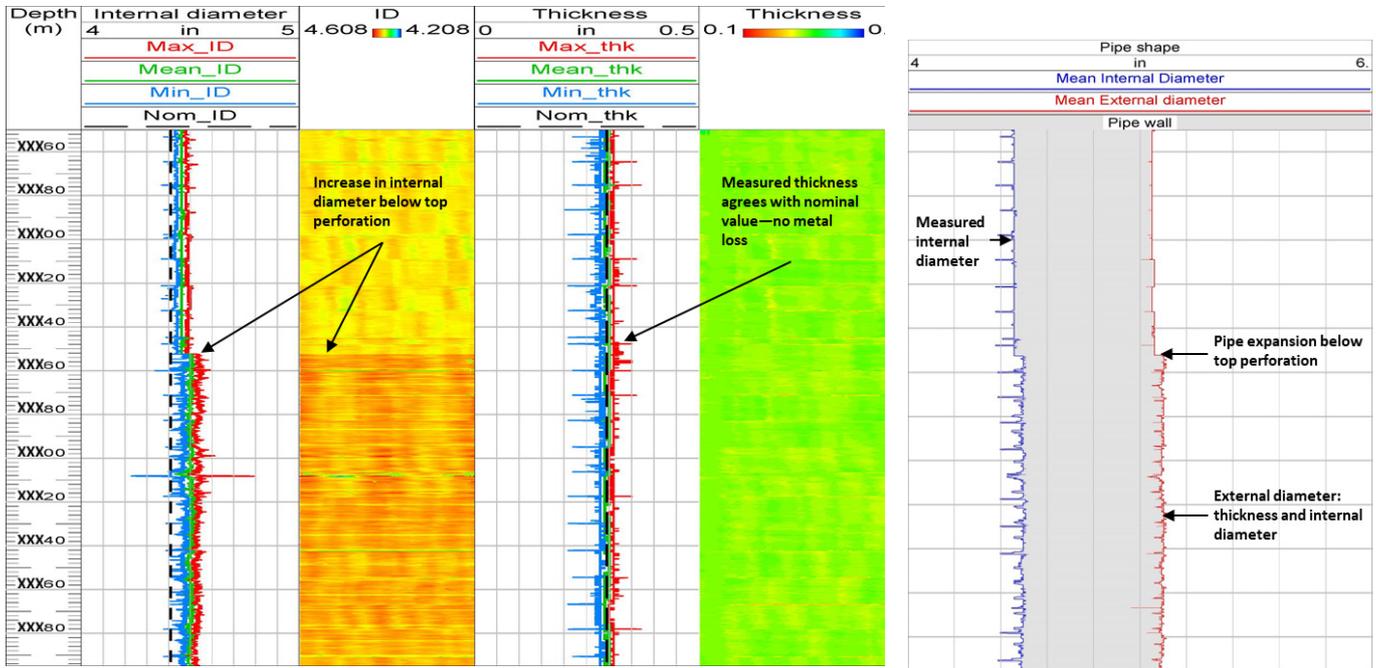
The survey showed that measured internal diameter above the perforated zone was close to nominal value, indicating no erosion the liner. Below the top perforation, there was a noticeable increase in measured ID, which if taken in isolation, would lead to the conclusion there had been significant erosion. However, the measured thickness showed no corresponding reduction which indicated that the liner had been “ballooned” out during perforating rather than eroded away, meaning that the well was being operated at a sustainable level.

Inner diameter and thickness comparison

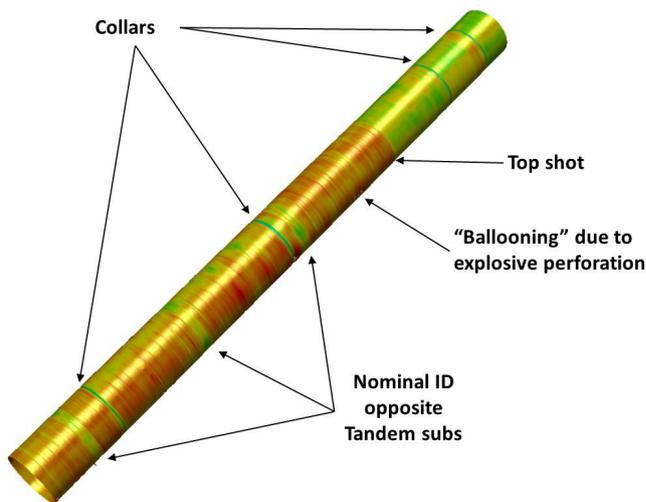
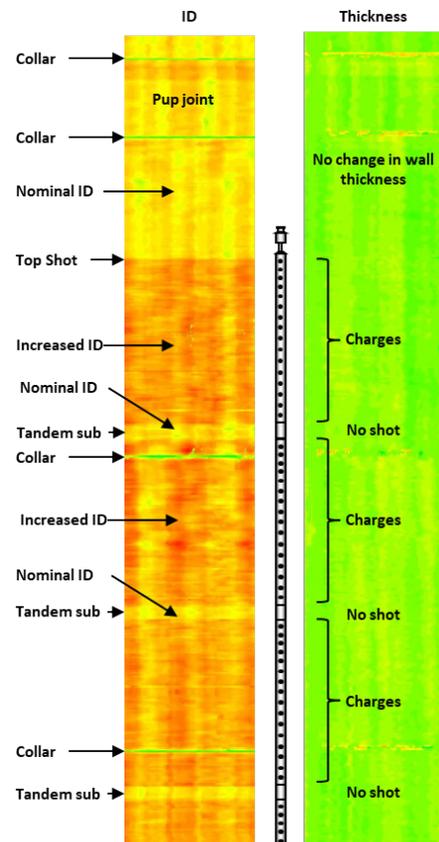
Average wall thickness profile

Expanding the depth scale reveals further features, such as a pattern in the liner expansion consistent with perforating gun bodies interspersed with tandem subs. The increase in internal diameter is only apparent where charges were present and not over the tandem subs which contain no explosive charges.
