# Tubing stump evaluation

## Measurement to optimise fishing

Case study: **SPACE® Focus**

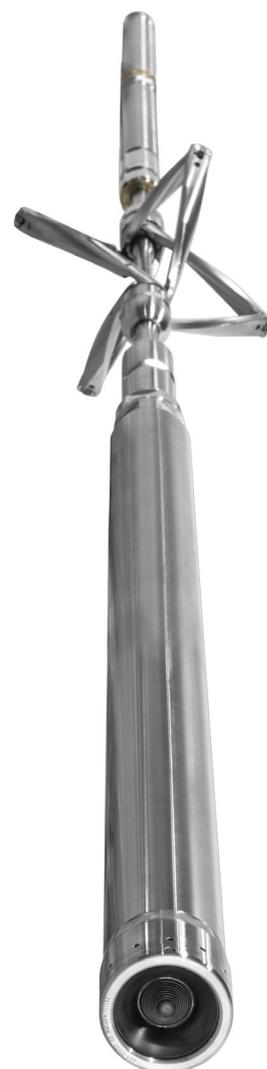
There was no reflection from the next 100° arc of tubing, indicating a total absence of metal. The interior surface of the 5-1/2" tubing of the overshot was clearly seen instead, and measurements confirmed its ID, unequivocally establishing that a large section of the tubing stump was missing.

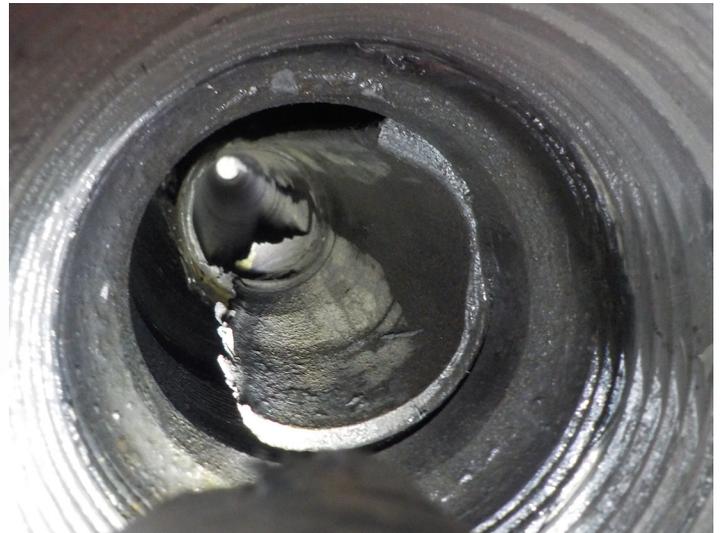
Retrieved stump in the overshot assembly
