# 50th wellbore Captured by SPACE®

Operational Milestone - **SPACE® Panorama**

Tubing collapse revealed on the 50th operational deployment of Archer's unique **SPACE®** service.

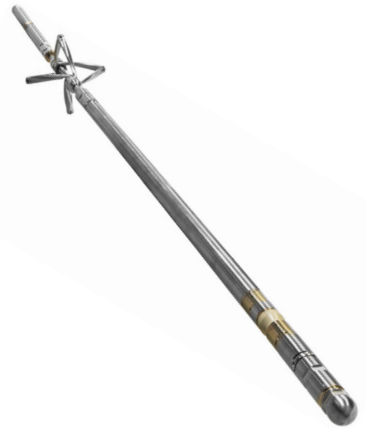
## Suspected tubing damage

A major international operator suspected collapsed or otherwise damaged tubing to be present in a well. SPACE® Panorama was chosen as the best option to properly evaluate the geometry of the damaged section inside tubing.

*Tubing starting to displace laterally*

*Maximum displacement*

*Deformation evident*

*Tubing collapse*
