## **Case study:** Tornar® Wellbore Cleaning Technology

# Fishing success in the North Atlantic region

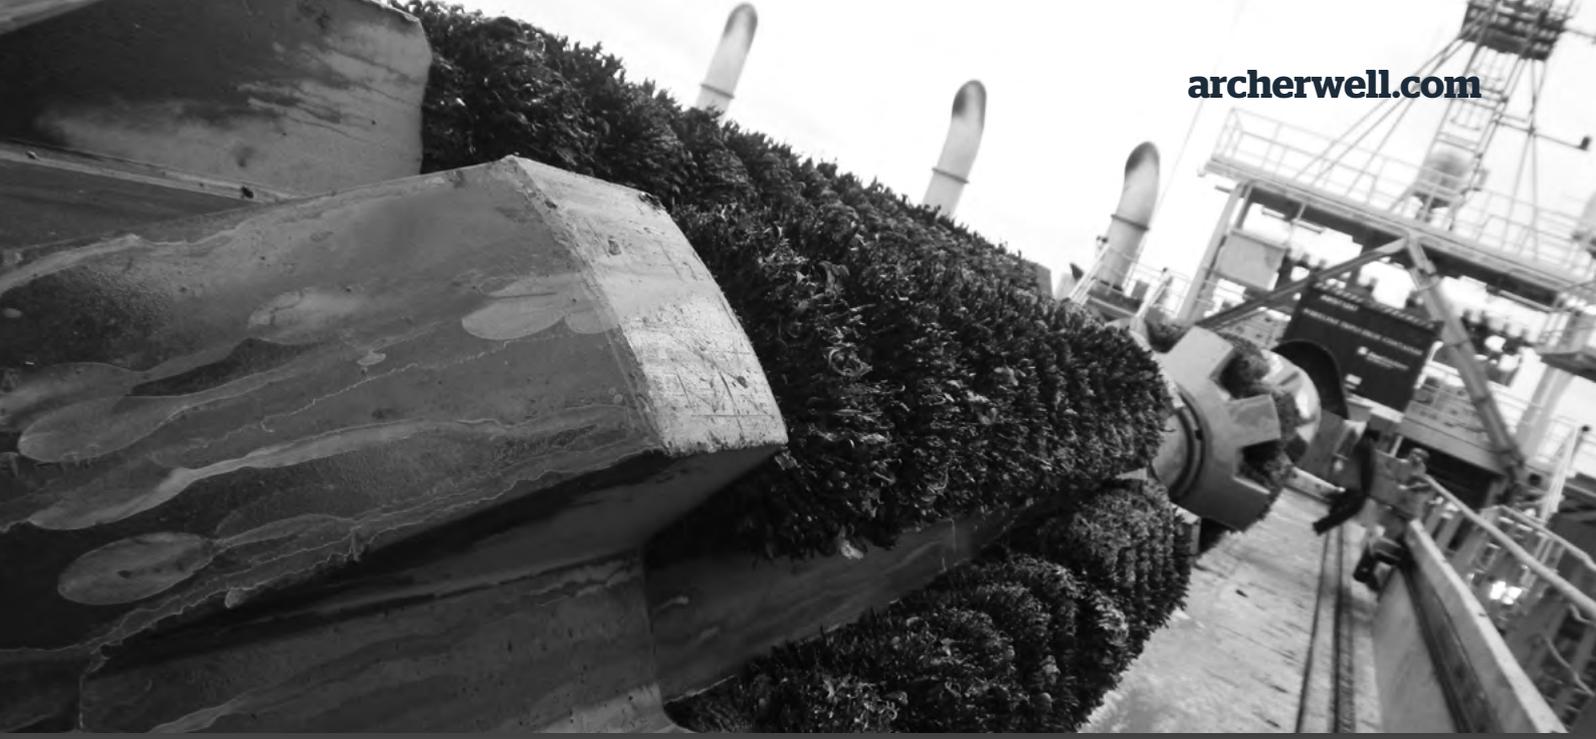
The Tornar BOP system exceeded expectations with its performance in debris recovery. The first run yielded a complete clamp recovered on the bottom of the circulating magnet (fig. 1). Further runs proved to be successful in recovering more metallic debris, including parts of the broken clamps from the BOP stack.

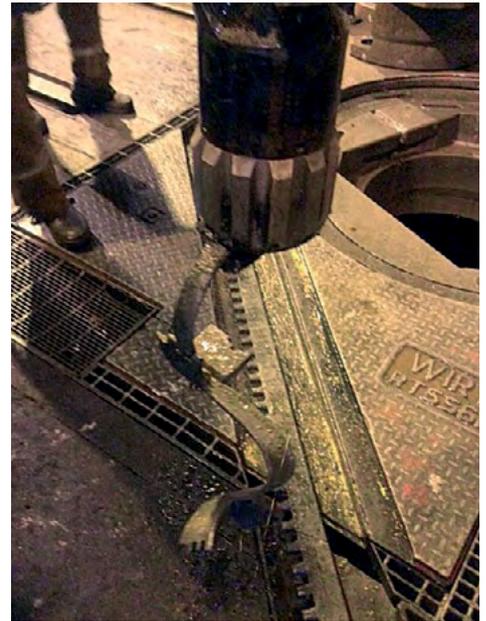
Fig 1. Clamp recovered on the circulating magnet.

The customer was confident that the BOP stack was free of debris and was able to proceed to function the stack without fear of damage and subsequent testing of BOPs. The circulating magnet was utilized on several additional runs due to its high capacity magnet (up to 1000 kg lifting capacity) and circulating rates (3200-5500 l/min).
