High-resolution measurements

to reveal damage to a TRSSSV

Case study: **SPACE® Vernier**

Region: North Sea
Customer: Maersk
Well Type: Producer

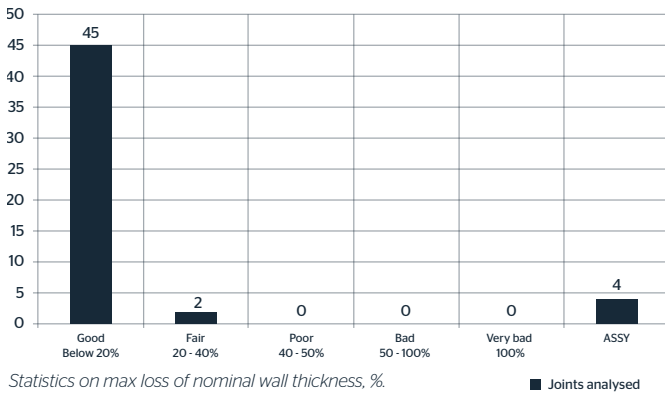
revealed reductions in remaining wall thickness of up to 21% at the point of the groove, while the remainder of the wall maintained largely nominal thickness. Taken together, the high resolution internal diameter and thickness data indicate that there is very little general corrosion or metal loss in the tubing as a whole, but that there is localised wall loss of up to 21% due most probably to physical wear.
