# **Tubing collapse during logging** Investigating a shallow restriction

## Case study: SPACE® Focus

A section of collapsed tubing above a DHSV is imaged and measured in high resolution by **SPACE® Focus**

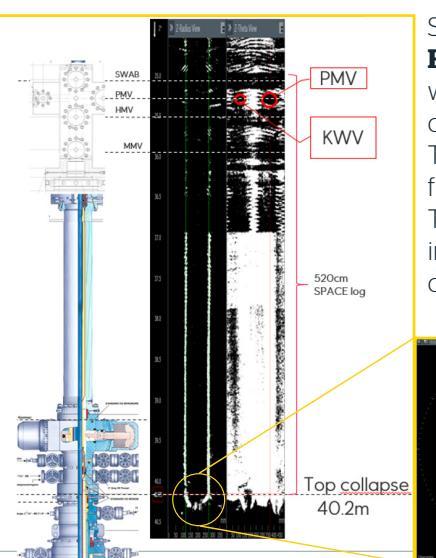
Composite of logged data with tree and wellhead

Since the collapse was so shallow, the **SPACE**<sup>®</sup> **Focus** tool was logged through the tree and wellhead to allow depth correlation and to allow the collapse to be oriented relative to the tree valves. The top of the collapse was found at 40.2m in the first tubing joint below the hanger. The tubing cross section clearly shows an indentation on one side protruding towards the centre of the tubing.

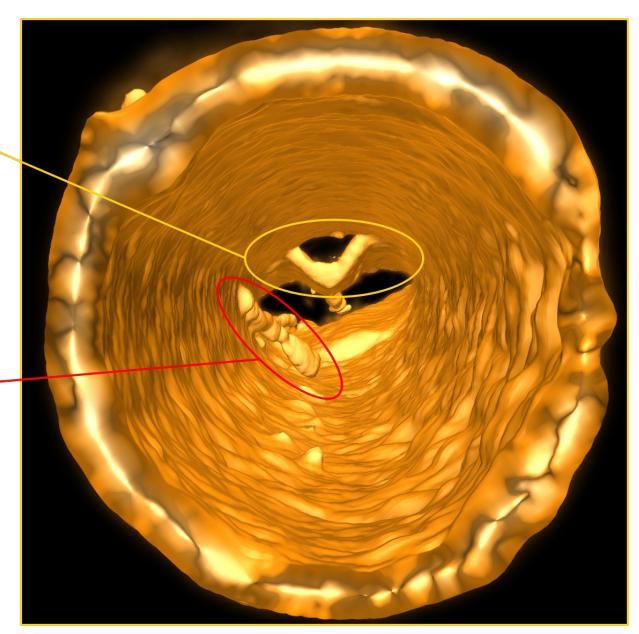
A detailed 3-dimensional rendering of the data was constructed to allow easy understanding of the geometry of the restriction.

The wall has been pressed into the interior of the tubing leaving an apparent hole, confirming communication to the annulus. Underneath this protrusion the tubing is also deformed, although to a lesser extent.

There is an object, which appears to be flexible in nature, extending upwards from the area of the collapse, which is likely to be a short section of wireline cable remaining in hole after the fishing job. Tubing wall pressed into interior, leaving a hole

Object protruding above the collapse depth

3-D rendering looking down to restriction

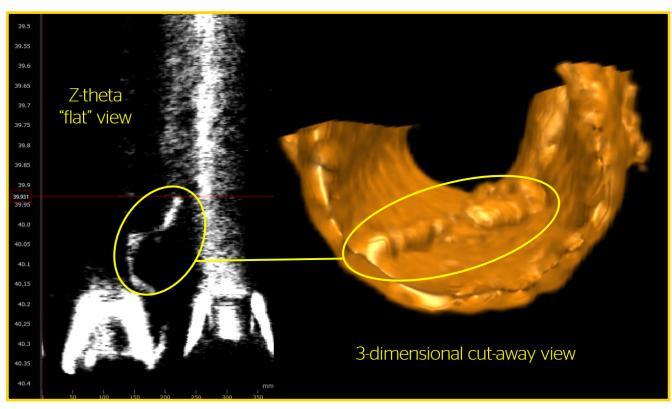
Flat and 3-D views

The visualisation software enables multiple views from differing aspects to be considered, and to zoom in on specific features to enhance understanding.

Examining the Z-theta "flat" view of the data shows the flexible nature of the object, which follows a sinuous path on the interior surface of the tubing.

A cut-away view in 3 dimensions gives perspective and an indication of the size of the object, the estimated diameter being around 10-15mm which is consistent with large electric wireline cable.

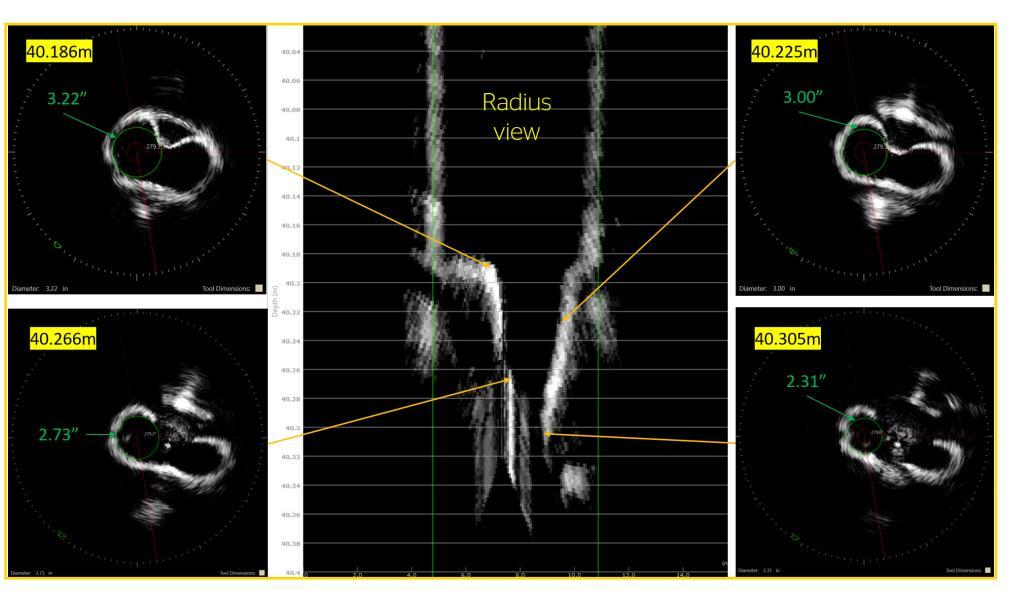
Combination radius view with cross-section views at different depths

Radius view can be used to visualise a plane cut down the axis of the borehole at any azimuth around the tubing. this view is useful in understanding the changes in ID with depth.

A cross-sectional view at any depth provides a complete ID map, which can be used to accurately measure critical dimensions of the collapse profile. Here, the effective size of the larger lobe between the protrusion reduces from 3.22" to 2.31" in a distance of 11.9cm.
