CASE STUDY- 2020- NORTH SEA

MCAP® provides annulus isolation in re-entry multilateral application

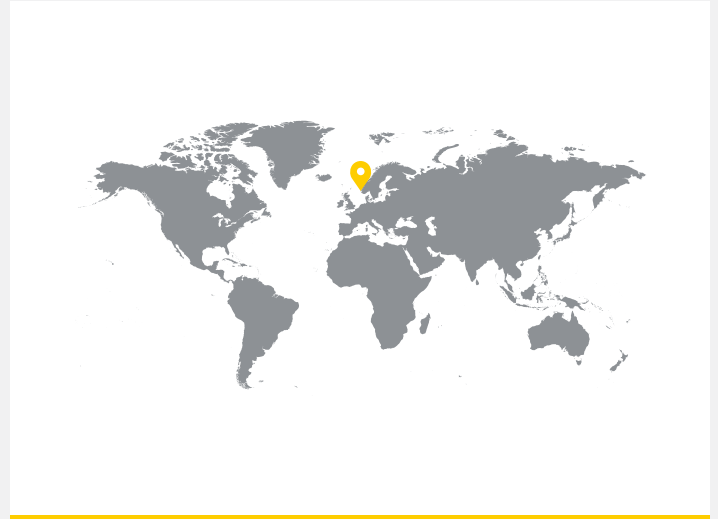
A major North Sea operator was re-entering a well that was 20+ years old and would be performing a sidetrack and installing multilateral (ML) equipment with a new reservoir target aimed at increasing production. This created a need to install a production tieback where there was not currently one installed. There were concerns with the condition of the previously installed PBR and if a positive seal was possible. The operator required a solution to be installed in the 9-5/8 casing and set in the 13-3/8 casing and provide the required isolation above the current liner top

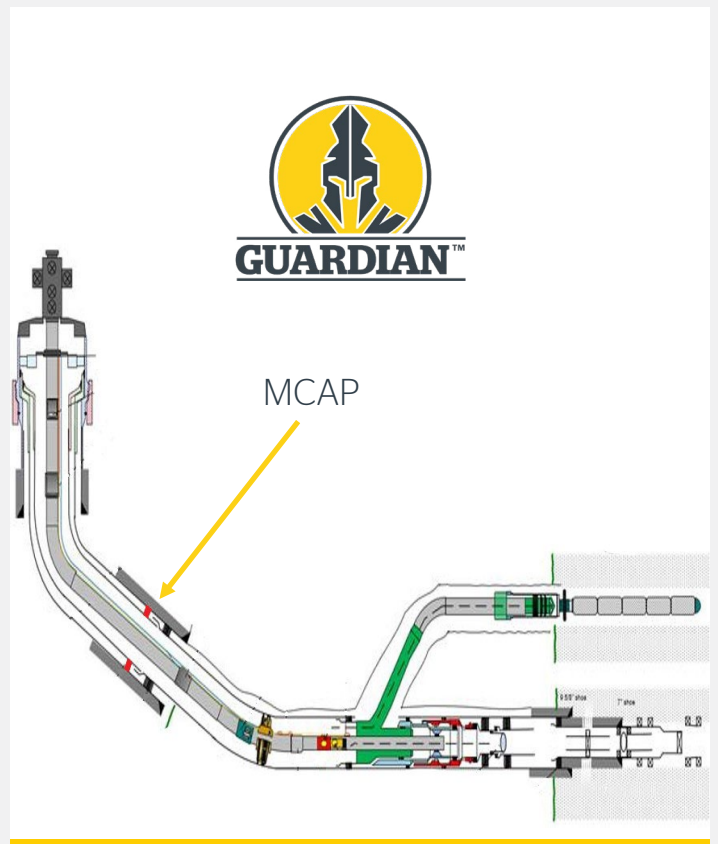
The MCAP was installed at the bottom of the tieback casing. The MCAP activation tool was run in tandem with the ML equipment and MCAP activated when tripping out of hole. MCAP was then tested via the casing annulus valve to confirm activation. The installation and activation of the MCAP was integrated into other runs therefor requiring no additional trips to perform the operation.
